OPOSSUM LAKE DAM

INVENTORY NUMBER NDS 584

PHASE I INSPECTION REPORT

NATIONAL DAM SAFETY PROGRAM

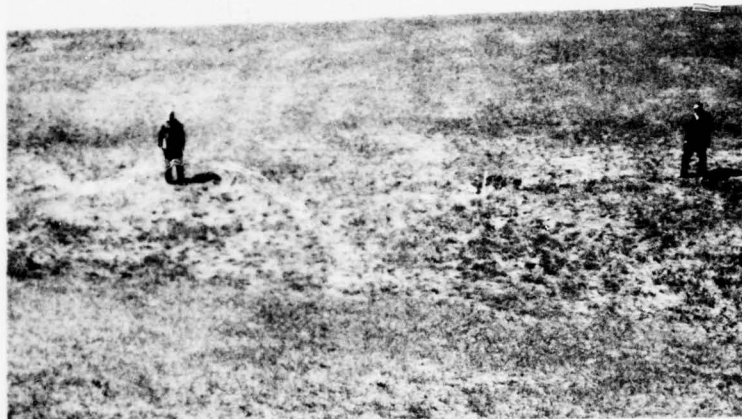
The inspection of the downstream slope revealed a seepage condition beginning approximately thirty feet horizontally from the toe of the embankment (Appendix D, Plate VII and VIII). This condition is accompanied with what appears to be sloughing. Discussions with a representative of the owner, in charge of maintenance and repairs explained that the disturbance on the slope surface was due to measures taken during the summer of 1976, when a subsurface drainage system was installed to control an apparent annually increasing seepage from this portion of the slope. As near as can be determined, the remedial action involved trenching near the toe of the slope and parallel to the dam axis over a distance of about 150 feet. This area crosses over the outlet pipe. Several lateral trenches, perpendicular to the main trench, were cut into the slope. A four inch perforated plastic pipe and stone backfill were placed in the trench and covered with topsoil. The lateral trenches appear to be coincidental with the observed sloughing areas. The primary drain was carried to the outlet channel and day-lighted just below the outlet works end wall. The measures taken are not entirely satisfactory as water still seeps from the toe of the embankment, even though the pipe discharging to the outlet channel is continuously flowing. (No measurement of flow made at this time).

Seepage Area

1. The owner should maintain a continuous surveillance of the dam until the dam has been rehabilitated to correct the serious seepage condition.

2. The quantity in gallons per minute of seepage exiting from the drainpipes should be measured and recorded daily and the turbidity of the water should be observed and recorded. If the seepage quantity increases by fifty percent from the initial readings or if the seepage is found to be cloudy, murky or containing fines; or if scarps or cracks develop on the embankment slope, the reservoir should be drawn down until the seepage stops.

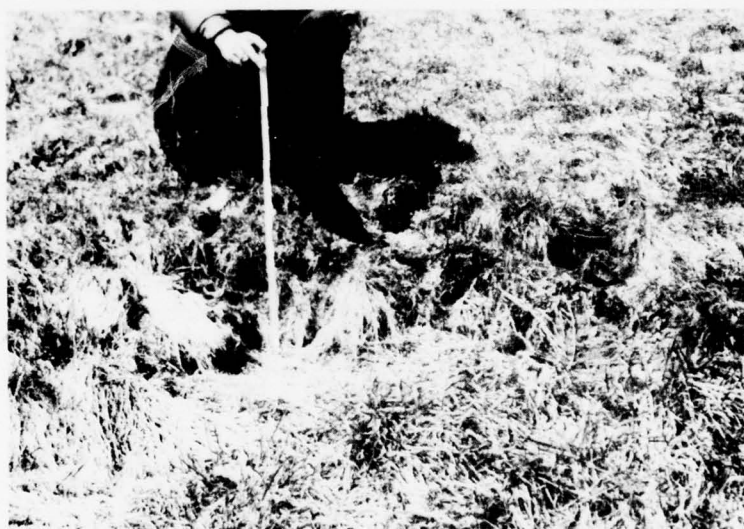
Of great concern was the noticeable seepage on the embankment slope over a considerable length and the wet areas in the filled-in area. The sloughage on the embankment was caused by the construction of the drain in 1976. The trench was filled with No.2 crushed stone and a perforated pipe. No graded filter was installed and the effectiveness of the drain has been reduced on the right side of the conduit and on the left side of the conduit the foundation drain is completely ineffective.

"Sloughage" and
Settlement due
to installation
of Drain

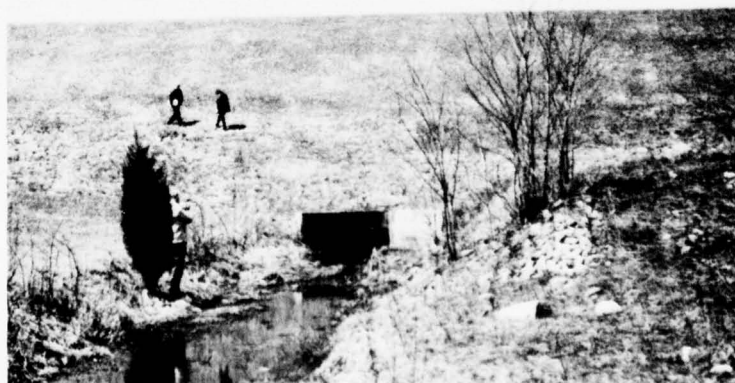
OUTLET WORKS	OBSERVATIONS	REMARKS & RECOMMENDATIONS
A. INTAKE STRUCTURE	Concrete tower in embankment with stop logs.	
B. OUTLET STRUCTURE	Seepage from embankment adjacent to outlet wing (right side) looking upstream	
C. OUTLET CHANNEL	Satisfactory - grassed, no large trees	
D. GATES	None - stop log control	
E. EMERGENCY GATE	None	
F. OPERATION & CONTROL	Removal of stop logs for fish management (up to 8' removed)	
G. BRIDGE (ACCESS)	None

Outlet Structure

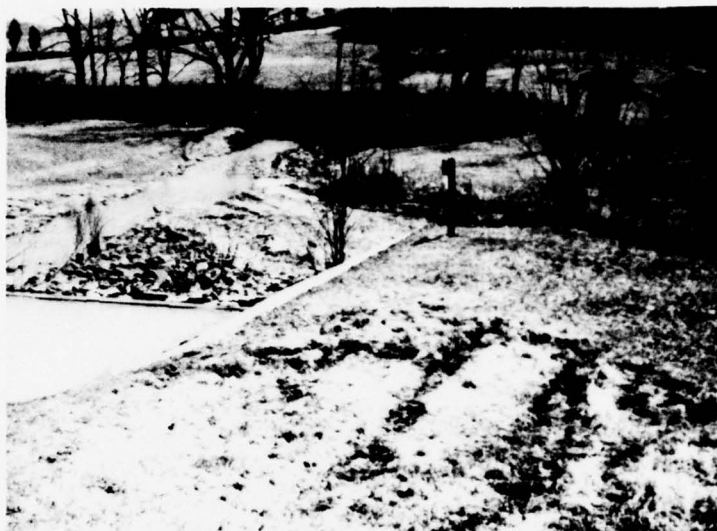
Downstream Channel
and Wet Area
